## Fasteners to concrete: failures & solutions

### CASE STUDY

#### 17<sup>th</sup> Bridge, Atlanta, US

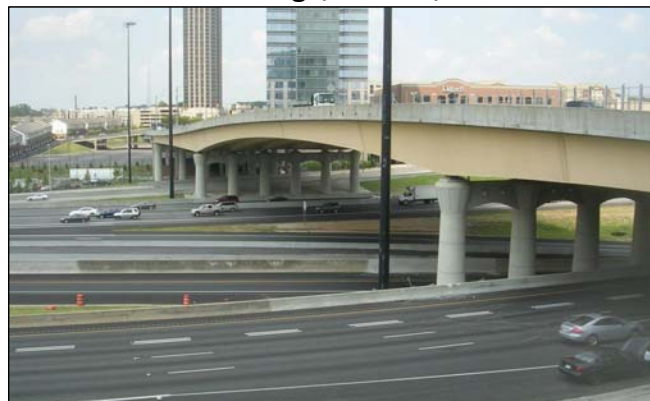
Source: 17<sup>th</sup> Street Bridge Canopy Failure Investigation, WJE Associates

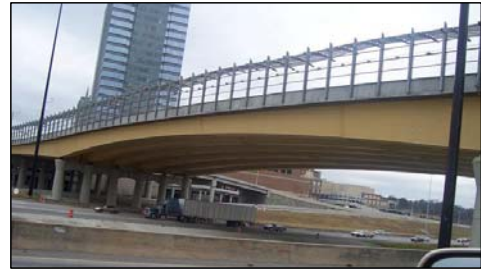
### Collapse

- 11.20pm, August 13, 2011
- 58m of the 213m length canopy-fence detached
- Canopy fence came to rest on the 20-lane Interstate Highway 75/85
- Nobody was injured, no vehicles damaged
- No high winds prior to collapse
- Maximum daytime temperatures ~34°C
- Southern aspect received greatest solar exposure

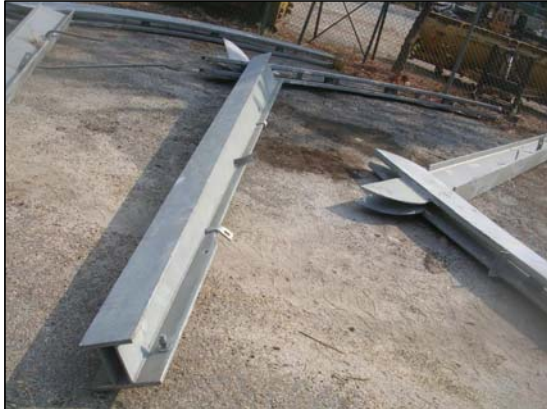
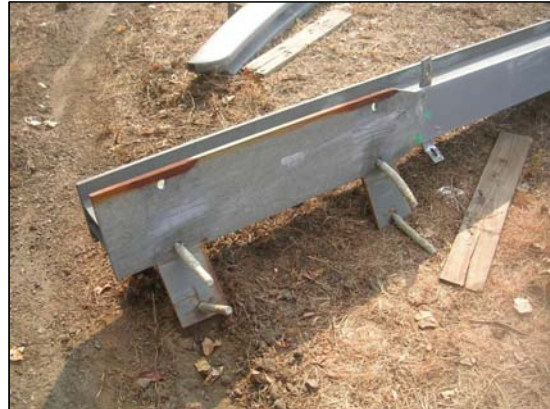
Source: 17<sup>th</sup> Street Bridge Canopy Failure Investigation, WJE Associates

- Canopy-fence frames:
  - ✓ 5.2 – 6.1 m high
  - ✓ 4.0 m overhang
  - ✓ 3.2 m on-centre
  - ✓ built-up steel column and cantilever beam
  - ✓ 2.5 x 2.5 inch (64 mm x 64 mm) tubes and perforated stainless steel sheets forming 'undulating' canopy
  - ✓ Fixed to south parapet via four chemical anchors

- 7/8 inches diameter
- 11 inches long, partially covered in epoxy
  - ✓ All-thread rods, or
  - ✓ 6 inches threaded rod plus 5 inches smooth (unthreaded) bar
- No observed cracking, tearing or distortion of anchor holes in steel frames

- 48/76 failed anchors were available for inspection
- Most anchor failures occurred in chemical product
- A number of failed anchors included smooth metal components
  - Mechanical interlock not possible
  - Significantly reduced bond capacity

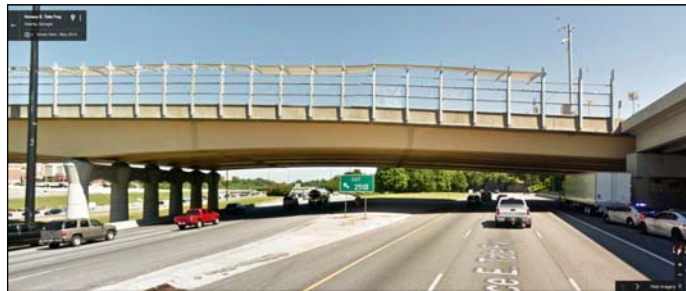
### Description of structure

- 6-lane overpass comprising steel box girders with a cast-in-place r/c concrete deck
- architectural fencing and pedestrian sun-shade canopy on south parapet
- construction completed in 2004

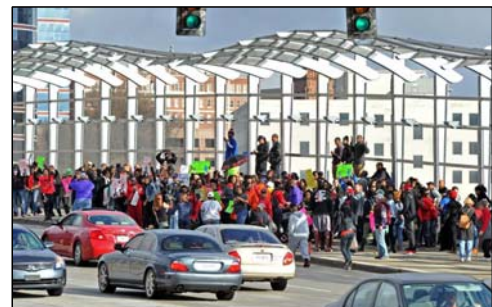
### Description of structure

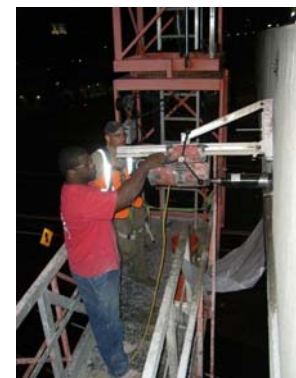
Coring

- Concrete strength = 46.8 MPa
- 6 core samples extracted from south parapet
  - ✓ 4 inch (100mm) samples
  - ✓ 5 samples made over vacated holes
  - ✓ No evidence of oil, grease or other contaminant in anchor holes
